QUINNIPIAC RIVER BASIN
BETHANY, CONNECTICUT

LAKE CHAMBERLAIN DAM
CT 00306

PHASE I INSPECTION REPORT
NATIONAL DAM INSPECTION PROGRAM

AUGUST 1978

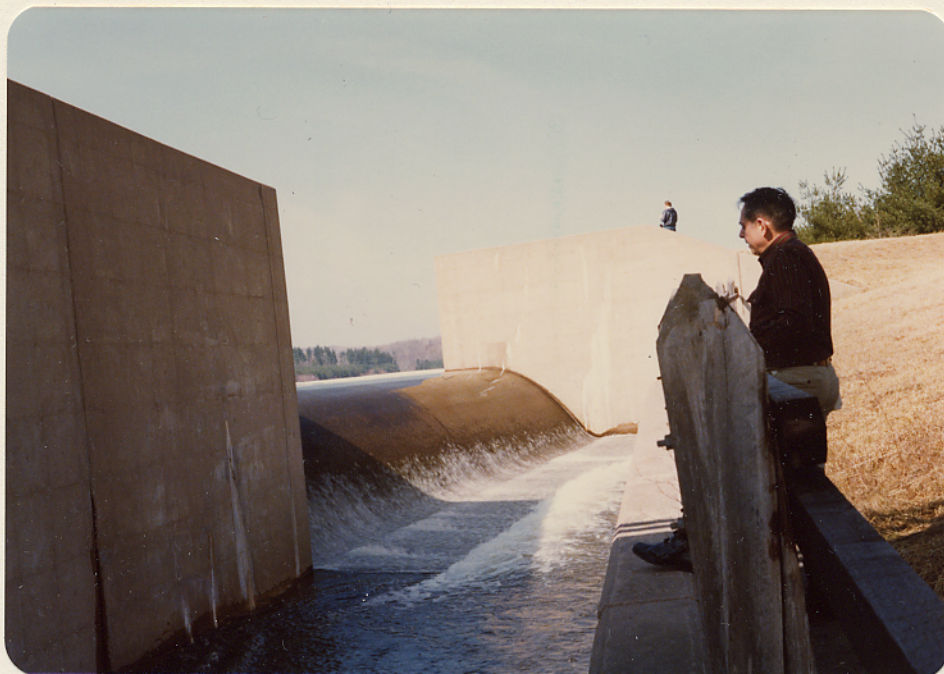
a. Visual Observations - From a structural standpoint, the dam, the spillway sidewalls and spillway channel all appear to be stable with no problems indicated. Some shifting of the channel wall has occurred at the construction joint on the landside of the spillway. The intake chamber is also in good condition, and does not appear to have any stability problems.

PHOTO NO.1 - Spillway and channel walls. Note cracks and efflorescence between panel joints.

3. The spillway channel wall on the left side at the construction joint should be observed periodically to determine whether or not further movement is occurring.
4. During the course of this study, it was brought to our attention that the New Haven Water Company has instituted a yearly program for inspection of all their dams, including Lake Chamberlain Dam, by a consultant competent in the field of dam inspection. This program, which has been in effect for the past two years, is commendable and should be continued in the future.

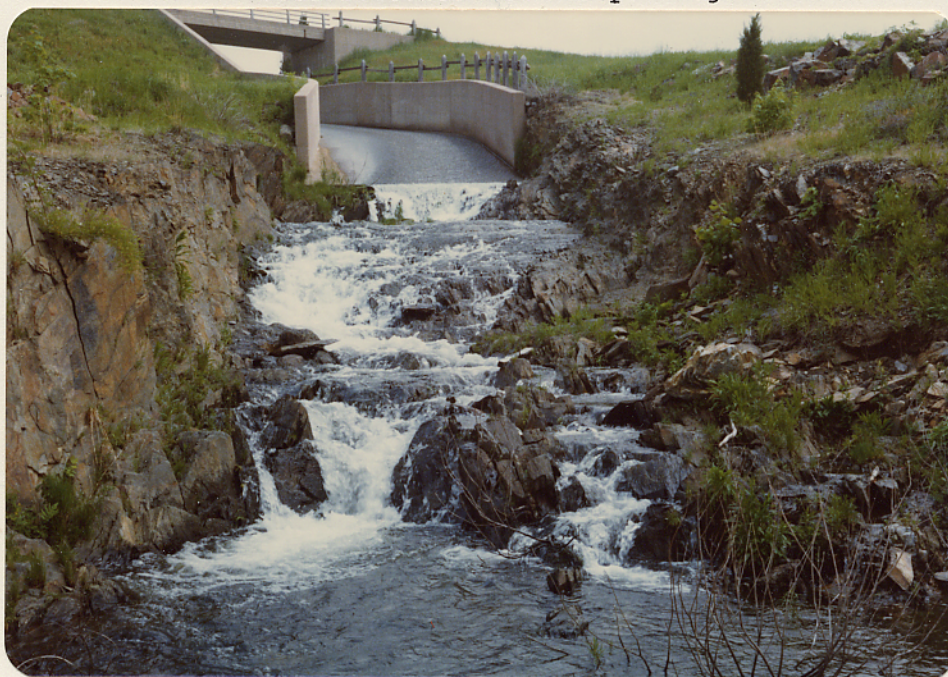
PHOTO NO.2 - Spillway channel cut into natural rock formation with spillway and bridge in background.

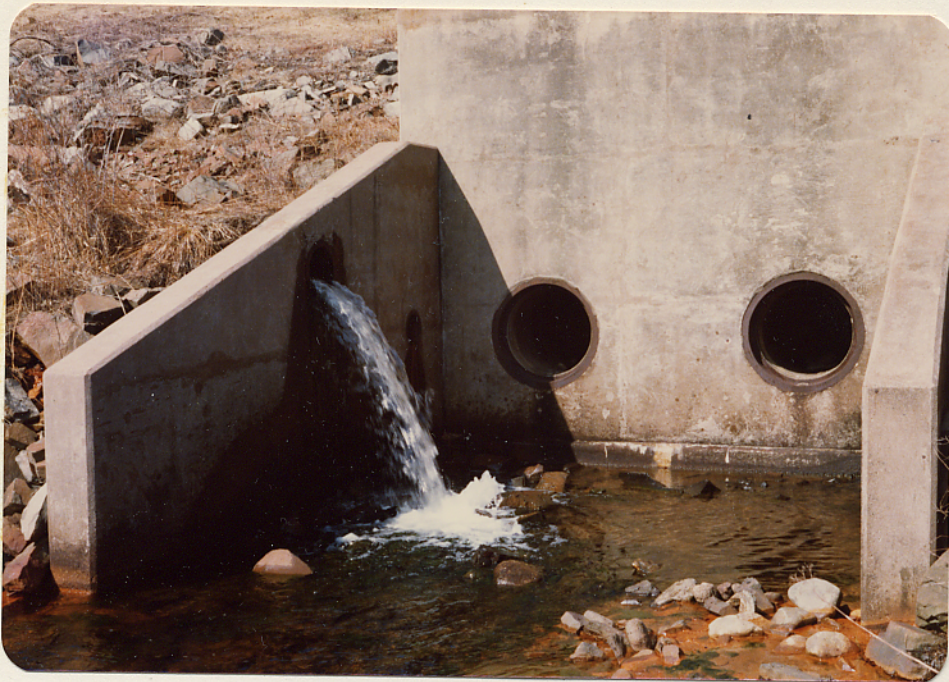
PHOTO NO.3 - Outlet structure.

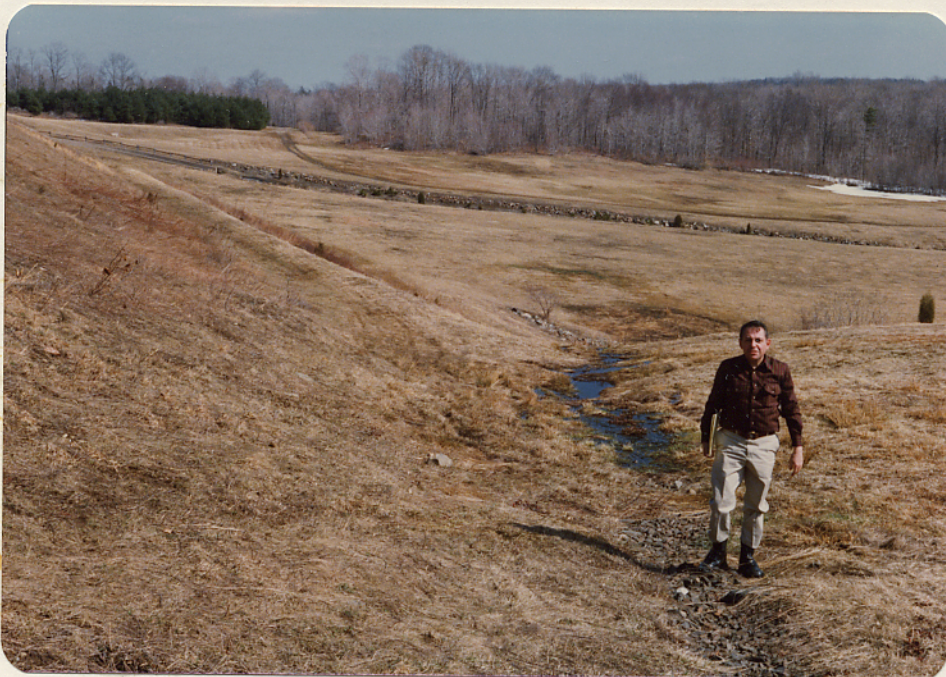
A seep was observed along the toe of the slope. Crushed stone was placed in the area of the seep, and water flowing due to the seep covered an area wider than that of the stone. The water appears clear, and no evidence of silt deposition was observed. It appears that the volume of flow increases as the stream travels along the toe, indicating that there is more than one source of water along the toe. The stream eventually discharges into the outlet channel about 20 feet downstream of the outlet structure.

PHOTO NO.4 - Seep and crushed stone downstream at right end of dam.

2. A program for monthly monitoring of seeps observed at the toe and downstream of the dam should be implemented. Monitoring should be visual to evaluate the turbidity of the water and should also include photographic evidence that would provide a record to detect large changes in the volume of flow or in the size of the wet areas from the time of one inspection to another. Presence of suspended solids in the water or substantial changes in flow not related to changes in reservoir level should be considered as indications of an unsafe conditions.
